# RENOVATION REPORT

## EXISTING SITUATION

A storage space is converted into a communal room for a residential complex. The room is located above a commercial space, under an existing green roof.

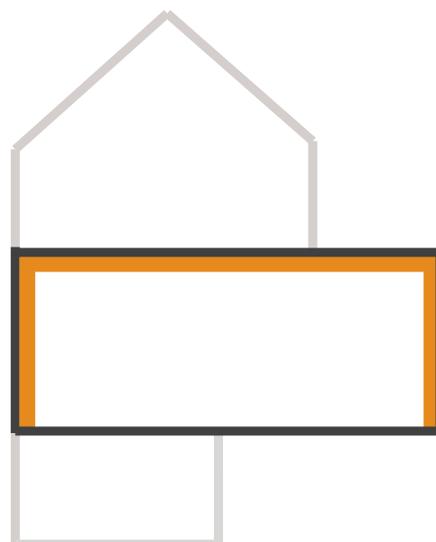
Section schématique de la typologie

Location of intervention	communal room
Affected floors	1
Housing units	20
Year of construction/major renovation	2019
Type of construction	Industrial construction using metal structures
Component to be insulated	roof and walls
Surface area of the envelope	200 M2
Points to consider	complexity of insulating corrugated steel roofing combined with a green roof

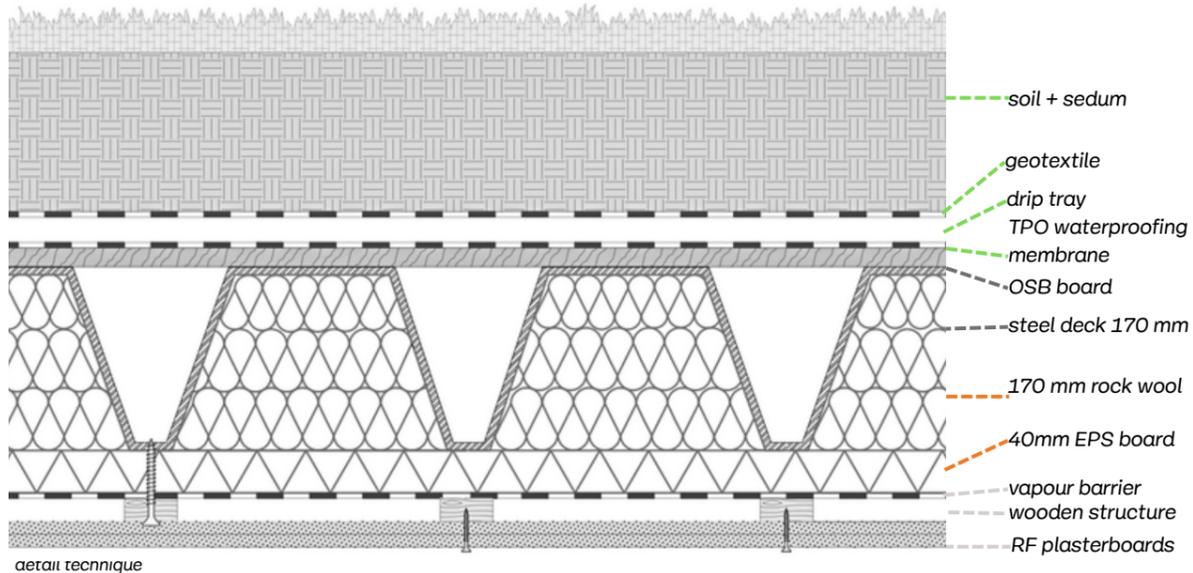
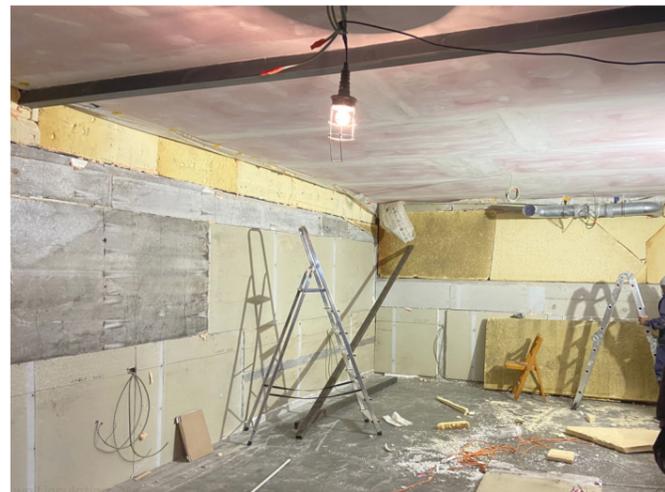
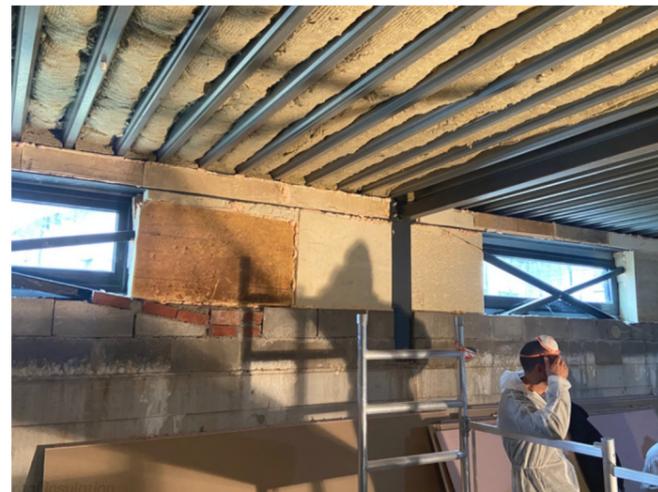
It is not generally recommended to insulate a flat roof from the inside, but in this case a green roof was already present, so it was not possible to insulate from the outside. Several preventive measures were taken to avoid issues with humidity in the roof composition. To avoid air pockets in the roof structure, rockwool was inserted between the grooves of the

steel sheet. Underneath the steel deck structure EPS boards of 40mm were placed. These were secured to the structure using a wooden frame. Due to the public nature of the space, double layered fire-resistant panels were used for the interior finishing, which were then plastered.

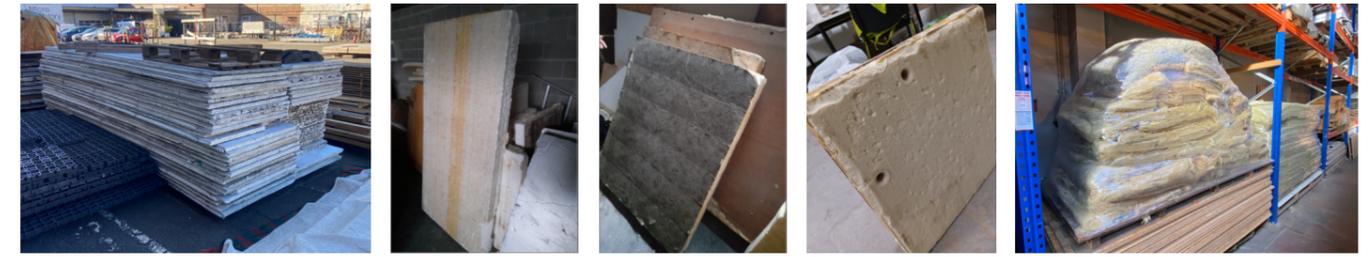
Both synthetic panels and mineral wool insulation were used in this project. The panels were donated by the non-profit organisation In Limbo. These panels vary greatly in size and have many irregularities. The EPS panels were recovered during the renovation of an industrial

warehouse. These thin sheets often need to be applied in several layers. However, they are quite large and have uniform dimensions, making the installation easier. In addition, two batches of rock wool were used. One is in relatively poor condition, the other in fair condition.

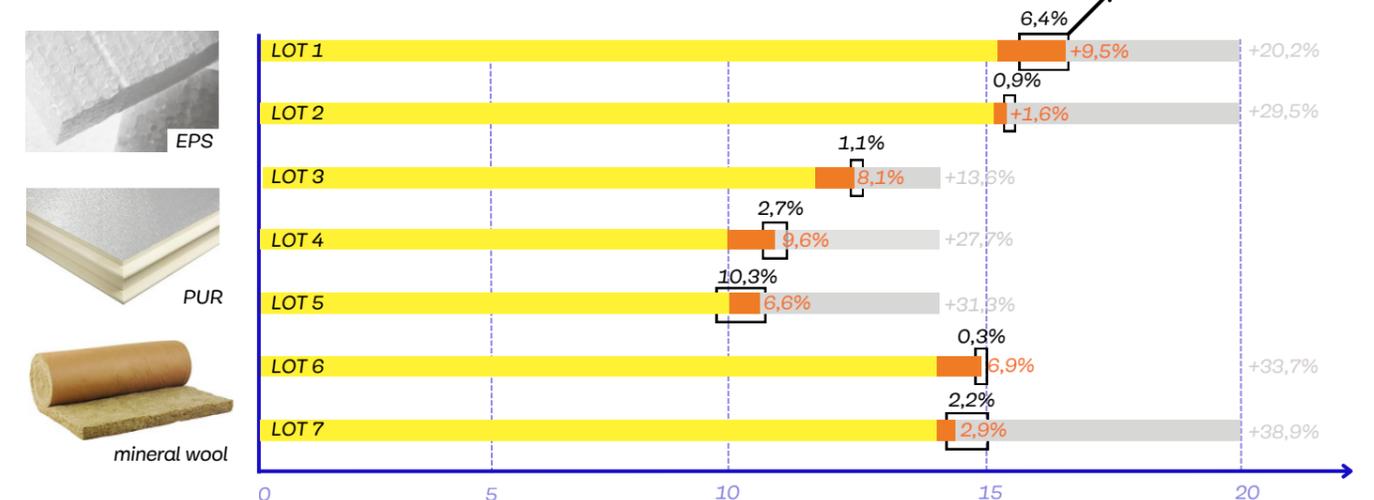
### Insulation thickness in cm to achieve a thermal resistance of R: 4 m<sup>2</sup>.K/W

The table below consists of two parts. First, it lists the materials used and their technical characteristics. Secondly, their thermal resistance is compared using different lambda (thermal conductivity) values and different thicknesses. The thickness of the insulation panels is calculated based on the thermal resistance of an equivalent new insulator (orange), the average measured value (yellow) and the default value (grey). If the technical information on an insulation material is

unknown or unavailable, a default thermal conductivity value from Annex A of Belgian standard NBN B 62-002 is used to calculate the thermal resistance. The thickness is calculated based on an R-value of 4m<sup>2</sup>.kW (this is the minimum thermal conductivity that applies in the Brussels RENOLUTION subsidy-scheme for roof insulation). The black box indicates the tolerance of the test-device to take into account for the results.
