# RENOVATION REPORT

## SITE 4

### OUTSIDE INSULATION OF A FLAT ROOF

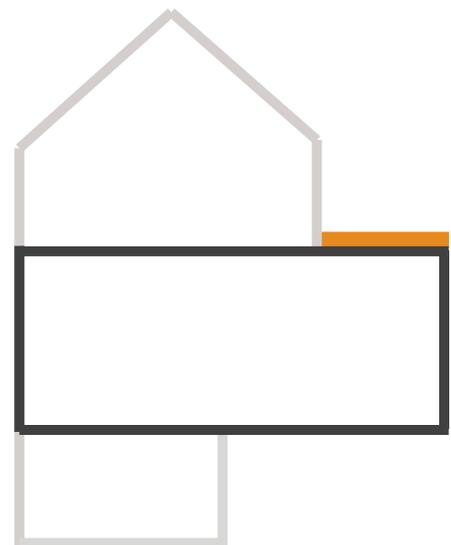
Section schématique de la typologie

Location of intervention	house with multiple units
Affected floors	3
Housing units	4
Year of construction/major renovation	<1930
Type of construction	roof with a wooden structure
Component to be insulated	roof extension rear façade
Surface area of the envelope	258 M2
Points to consider	The height between the window and the roof is not always sufficient.

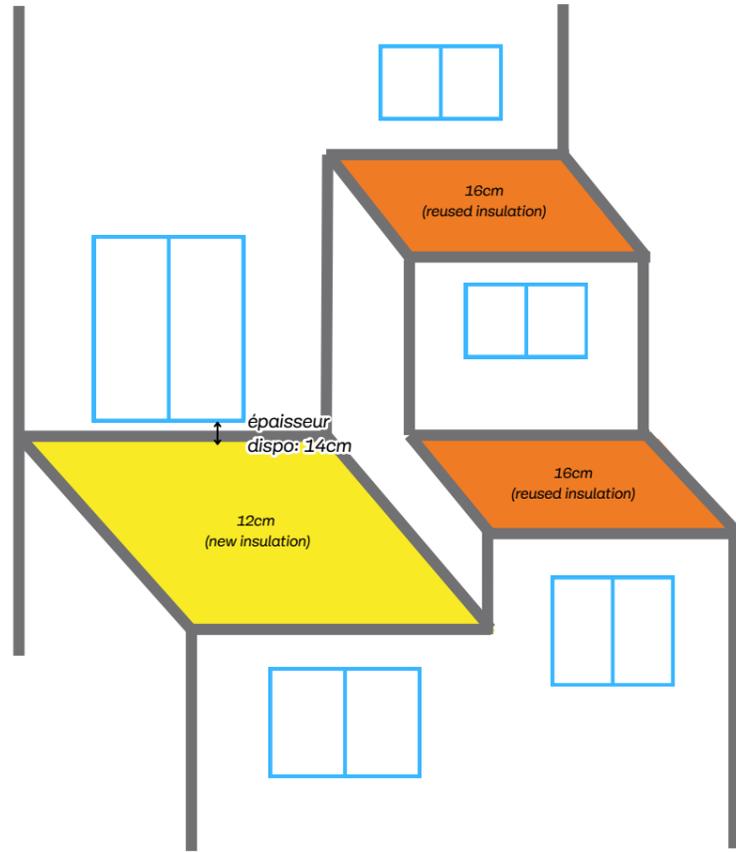
simplified diagram of reused insulation

There are three surfaces, one of which was insulated with 12 cm new insulation to achieve optimal insulation, as there was only 14 cm of height available between the window and the roof. The other two surfaces were insulated with two layers of 8 cm reused PIR panels.

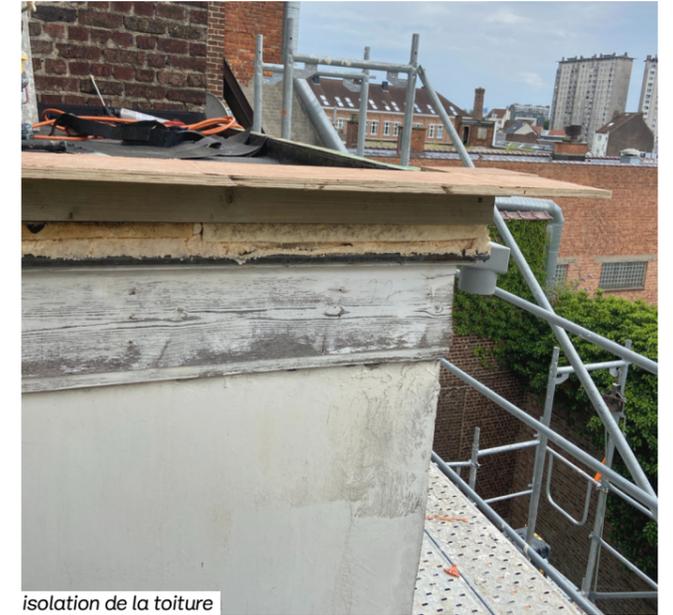
isolation de la toiture

Synthetic PIR panels were used to insulate the flat roof. They had some irregularities and adhesive residue. These had to be filled or removed to achieve a flat surface and prevent air from getting trapped between the layers of the various roof materials.
