RENOVATION REPORT

SITE 8

INSULATION OF ROOF FROM THE INSIDE

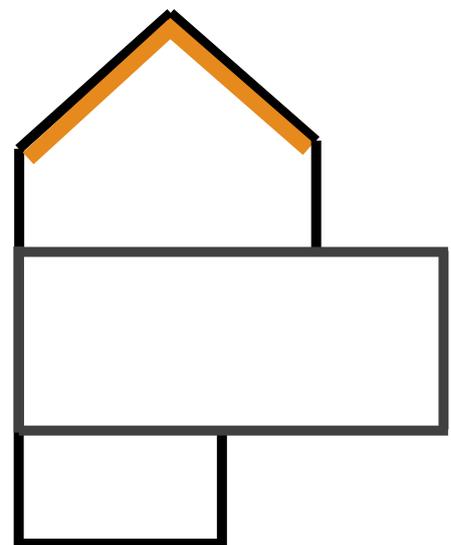
Section schématique de la typologie

Occupied attic space, with a bedroom and bathroom. Historic dormer window on the street side.

Location of intervention	single family housing
Affected floors	3
Housing units	1
Year of construction/major renovation	1898
Type of construction	timber frame
Component to be insulated	roof
Surface area of the envelope	150
Points to consider	slightly damaged roof-underlayer

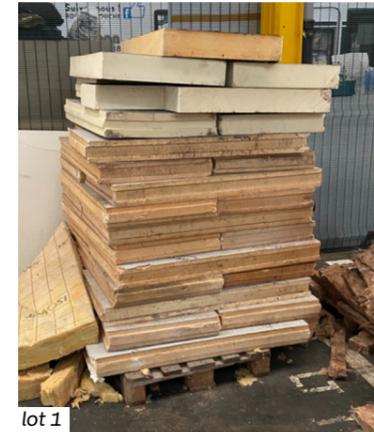
lot 1

<p>average</p> <p>The rock wool and PIR panels were in very good condition. The PIR panels even still had their tongue and groove. The PUR panels, on the other hand, were in poorer condition. They still contained bitumen residues, which had to be removed.</p>	<p>sample preparation</p>

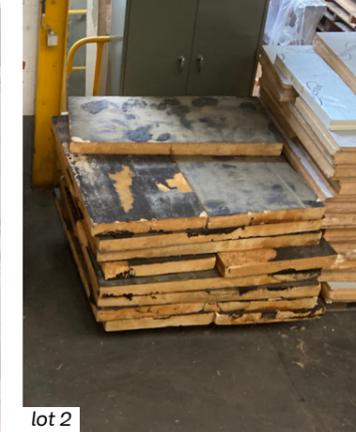
lot 2

<p>average</p> <p>The rock wool and PIR panels are in very good condition and therefore only slightly deformed. The PUR panels, on the other hand, were in poorer condition and more deformed along the edges, with some of the thickness lost due to the continuous weight applied on the surface.</p>
