RENOVATION REPORT

The renovation reports are grounded in the findings of the pilot projects conducted as part of the ISOL'ution project. They synthesise practical lessons learned and identify key considerations for the reuse of insulation materials in various building typologies and material types.

SITE 2

ISOLATION OF A PITCHED ROOF

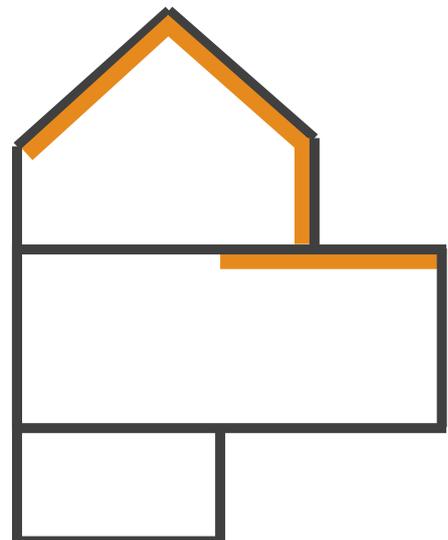
Section schématique de la typologie

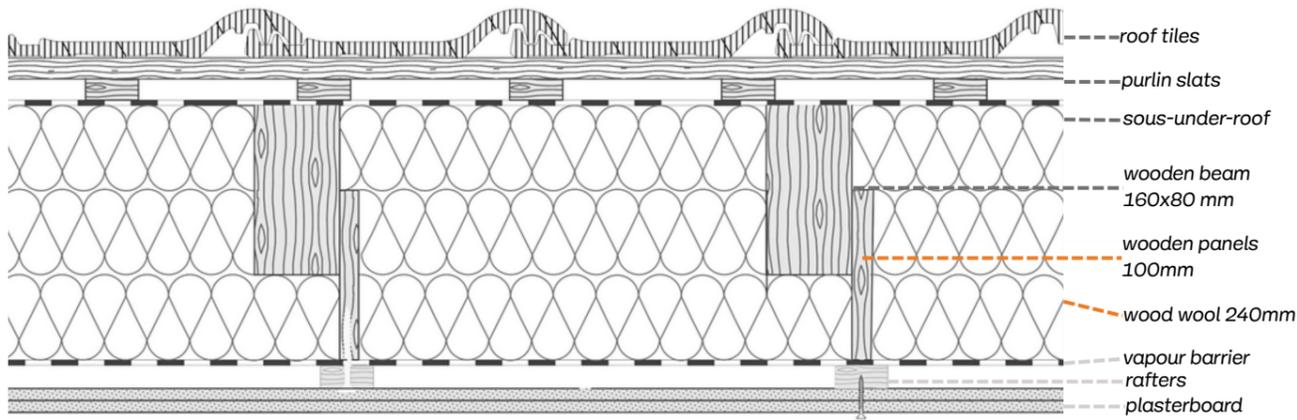
The existing wooden frame was partially extended in order to achieve sufficient room for the insulation. Bio-based insulation mats are inserted between the beams. The creation of a terrace within the roof volume requires particular attention to the connection between the insulation. In order to ensure the continuity of the thermal envelope and avoid thermal bridges, the insulation overlaps by at least 1 metre on the ceiling of the lower level.

technical detail

<p>solved</p> <p>When creating a terrace in a building (where external insulation is not possible), it is essential to overlap the insulation of the ceiling of the lower floor by at least 1 meter. The elements used to extend the beams must be thin in order to avoid thermal bridges.</p>	<p>insulation continuity</p>

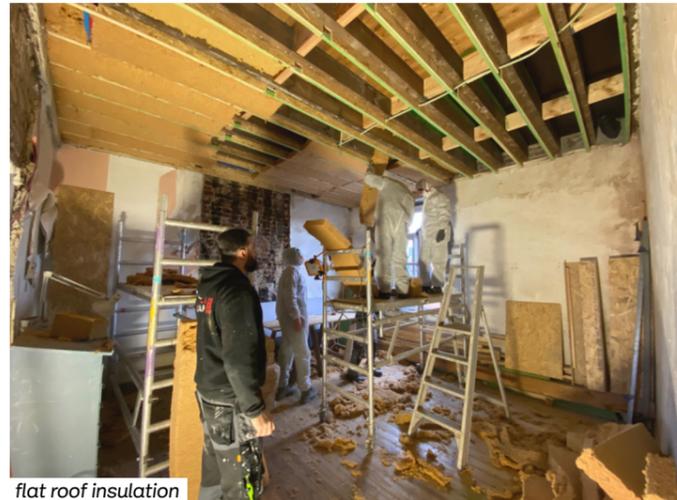
flat roof insulation

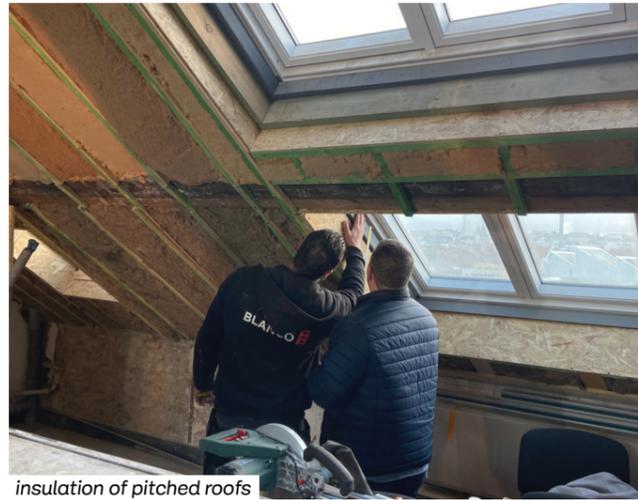
insulation of pitched roofs

<p>between structure</p> <p>The insulation is inserted between the structural beams of the roof, which have been extended using OSB panels to achieve a thickness of 24 cm. Once the airtight seal has been achieved, battens are installed to hold the insulation in place and secure the finishing panels.</p>	<p>measurements</p>

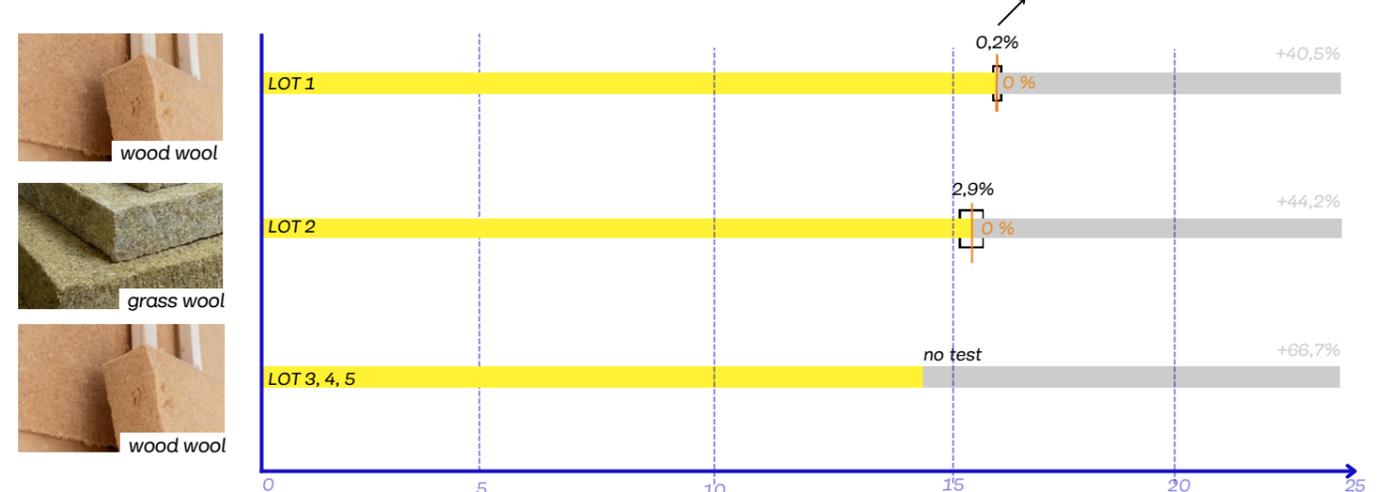
The table below consists of two parts. First, it lists the materials used and their technical characteristics. Secondly, their thermal resistance is compared using different lambda (thermal conductivity) values and different thicknesses. The thickness of the insulation panels is calculated based on the thermal resistance of an equivalent new insulator (orange), the average measured value (yellow) and the default value (grey). If the technical information on an insulation material is

unknown or unavailable, a default thermal conductivity value from Annex A of Belgian standard NBN B 62-002 is used to calculate the thermal resistance. The thickness is calculated based on an R-value of 4m².kW (this is the minimum thermal conductivity that applies in the Brussels RENOLUTION subsidy-scheme for roof insulation). The black box indicates the tolerance of the test-device to take into account for the results.

Insulation thickness in cm to achieve a thermal resistance of R: 4 m².K/W

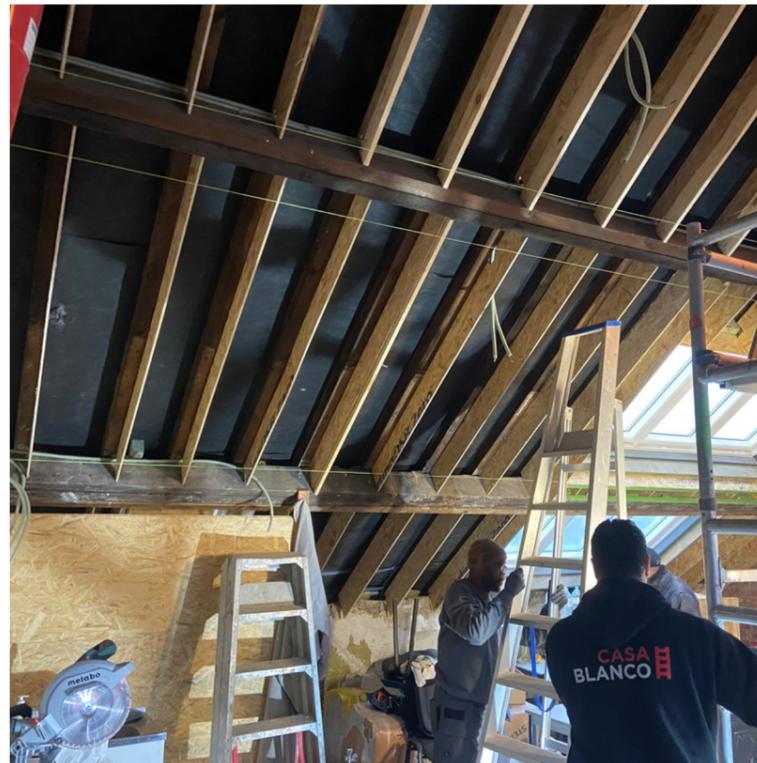
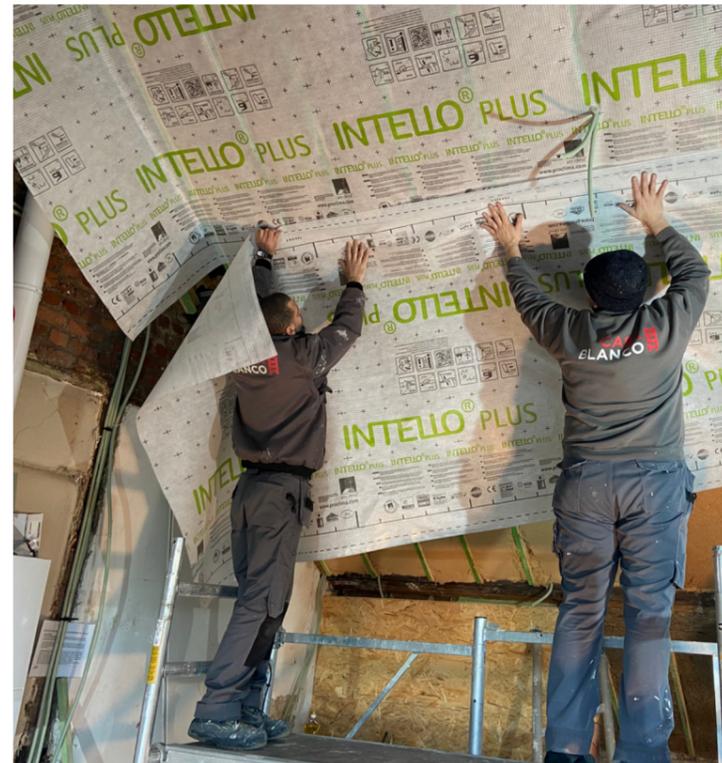
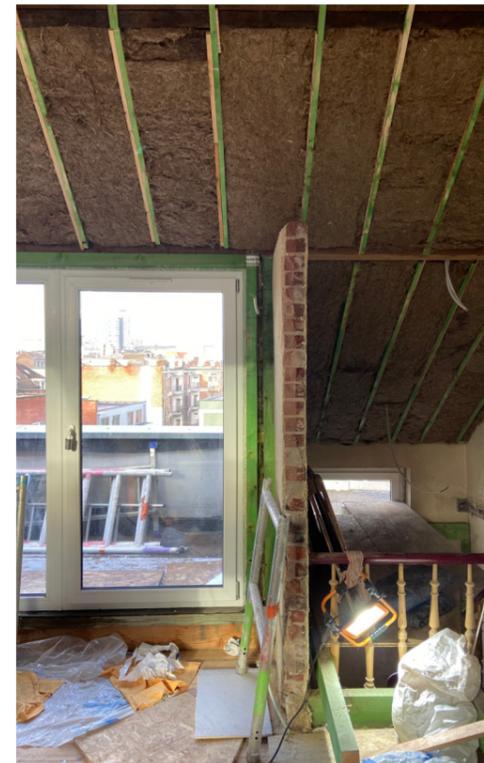
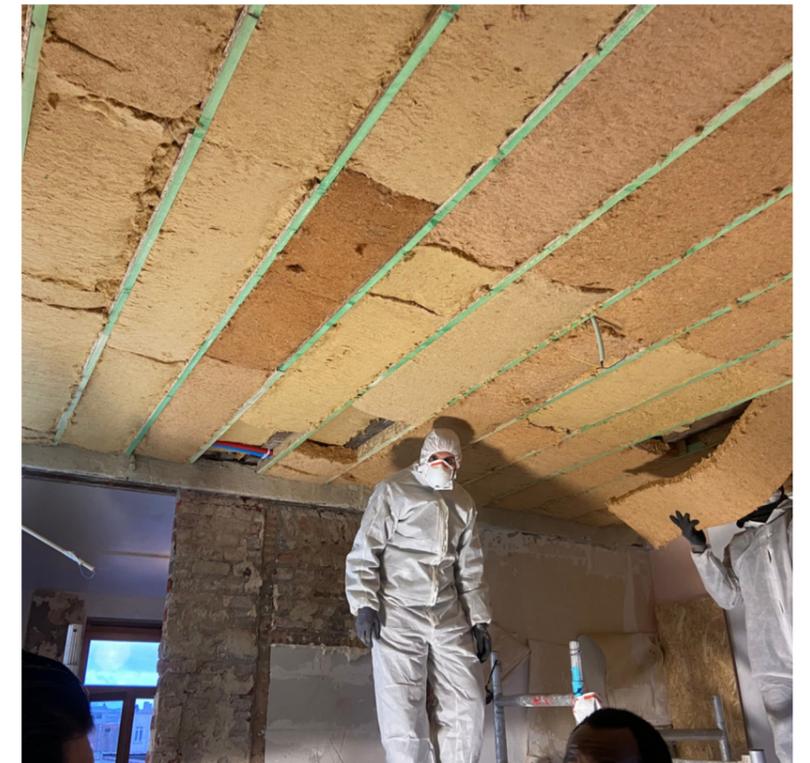
ON THE INSIDE + woodwool and grass wool insulation +vapor barrier	98 m ²	lambda: 0,038 R: 6,84	PRICE: 83,6€/m ² : 9078,50€ I: 32€/m ² : 3136€ M: 57€/m ² : 5529€ L: 41 €/m: 4018€	<p>maintenance 0,7</p> <p>waste 1,32</p> <p>production 0,8</p> <p>energy 4,9</p>	<p>materials 2,82</p> <p>energy 4,9</p> <p>insulation 0,88</p> <p>7,72</p>	126,94 kgCO ₂ eq/m ²	0,19 W/m ² ·K
