RENOVATION REPORT

SITE 3

INTERNAL INSULATION OF FAÇADE

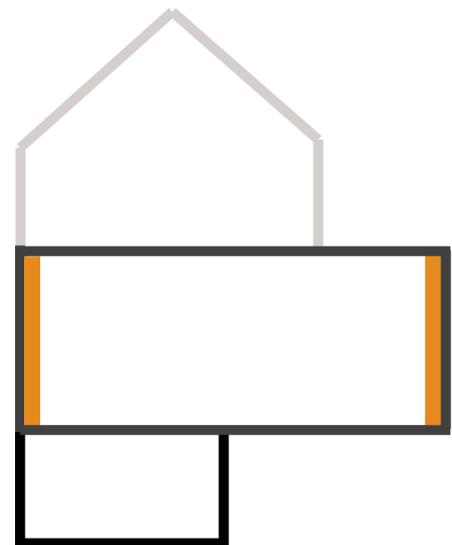
Section schématique de la typologie

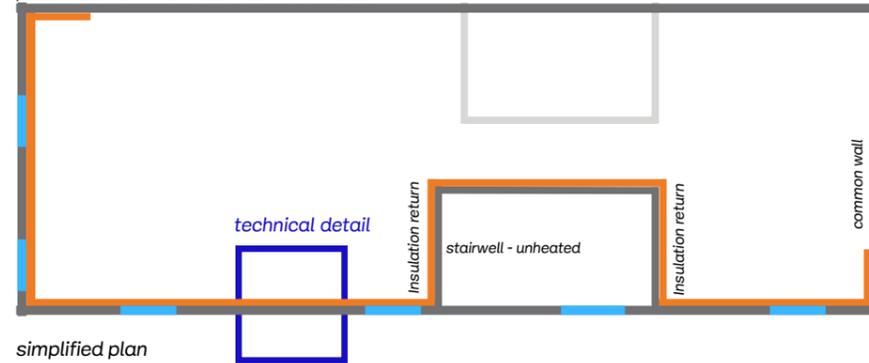
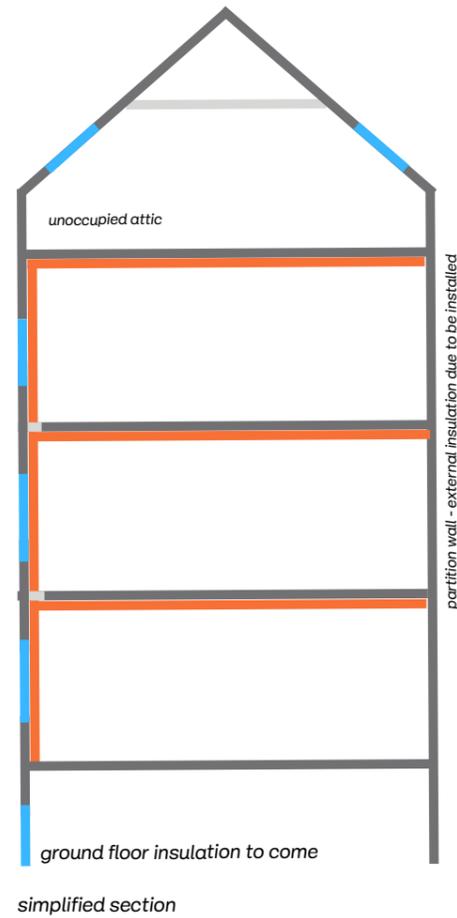
● window ● reused insulation ● structure

partition wall - external insulation due to be installed

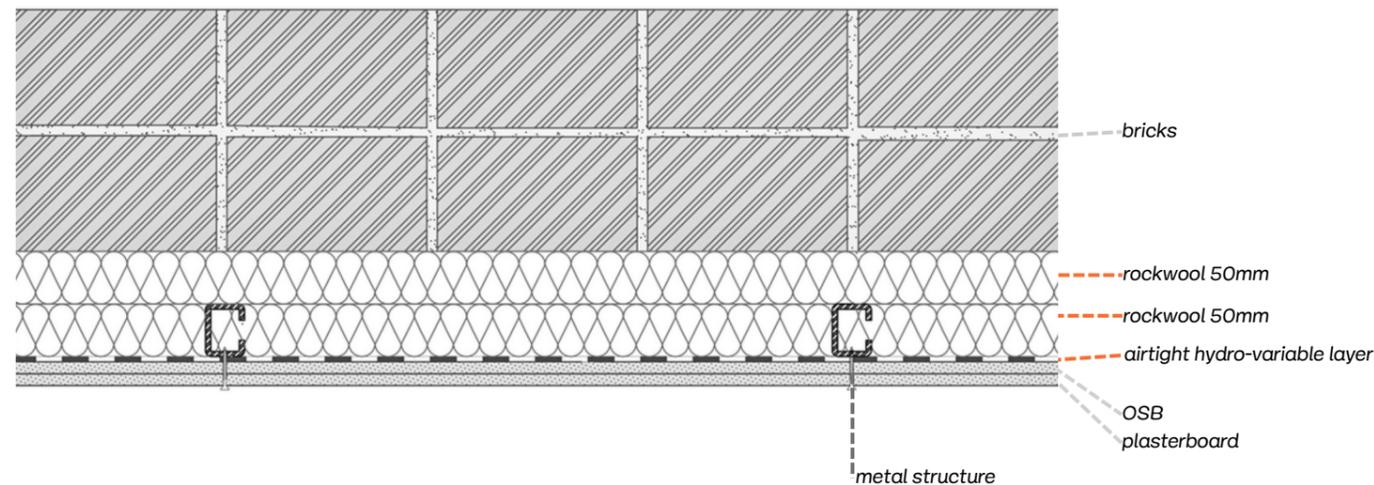
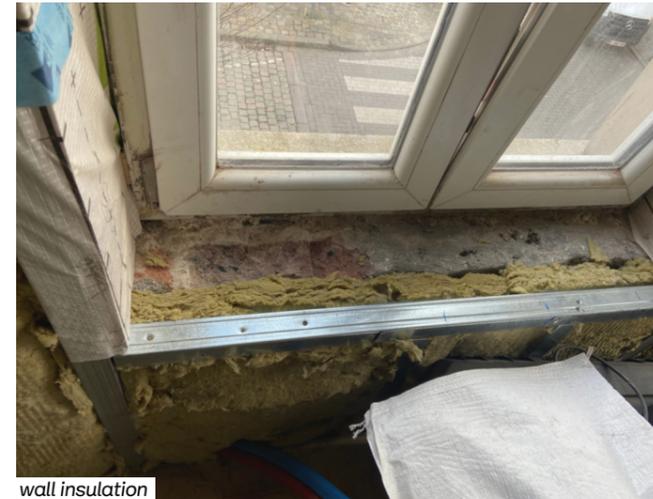
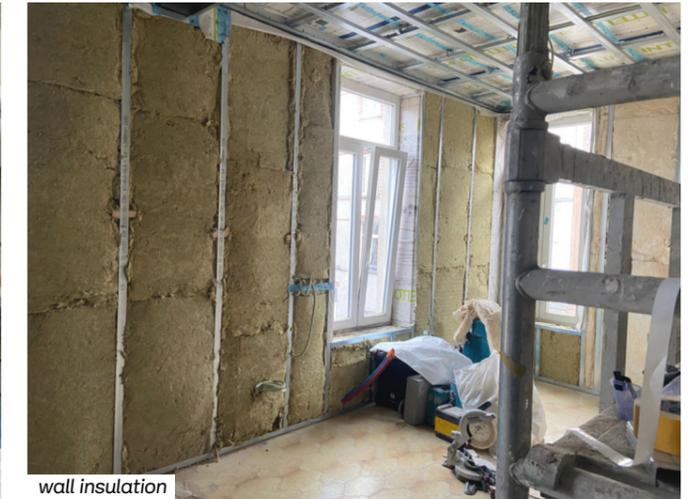
Technical detail explanation

A double layer of rock wool, each 5 cm thick, was chosen to ensure continuous insulation across all levels, facilitated by the complete renovation with the opening and insulation of the floors. A metal frame, fixed to floor and ceiling, holds the insulation panels in place, while wooden wedges ensure the structure is securely fixed and stable on the

walls. Opening up the floors allowed for the airtight encapsulation of the wooden beams integrated into the façade, thus protecting these elements from moisture damage. The vapour barrier completes this system, controlling moisture exchange and contributing to the health of the occupants and the interior insulation.

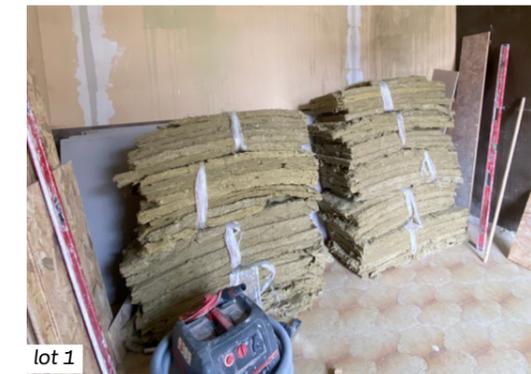
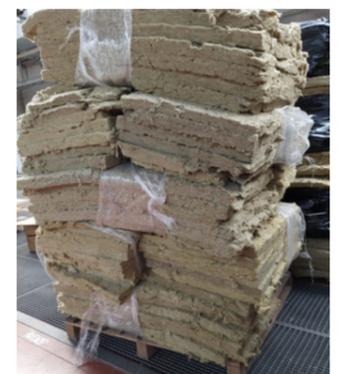
Rock wool was chosen for insulating this façade because it is easy to install in a partition wall. As the budget allocated for insulation on the project was limited and the surface area to be insulated was large, rockwool was the obvious choice. This material is available in large quantities on the reuse market at a reasonable price. Most of this material is recovered from the demolition of office partition walls.

<p>average</p> <p>The condition of the recovered insulation can vary greatly. In this case, some of the insulation mats had significant rips. However, due to the flexible nature of the insulation, the deformations did not pose any major problems during installation. The mats were not packed in an airtight way, which resulted in a noticeable amount of dust in the material.</p>	<p>sample preparation</p>

<p>average</p> <p>The insulation has lost some of its thickness, and its corners were sometimes deformed or damaged.</p>
<p>availability</p>

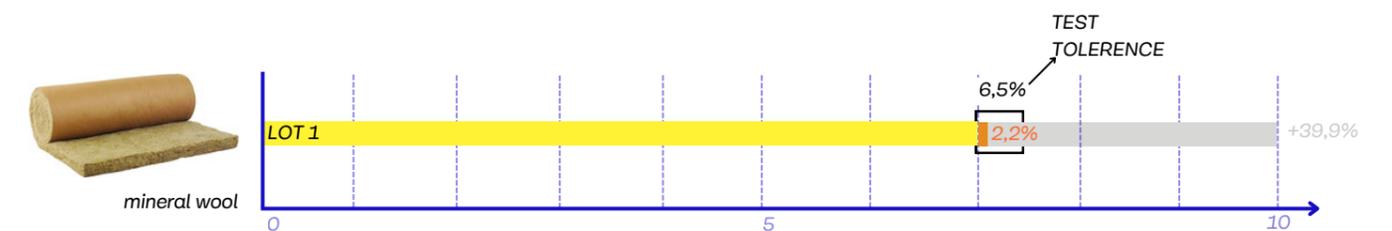
Test results of the thermal conductivity

The table below consists of two parts. First, it lists the materials used and their technical characteristics. Secondly, their thermal resistance is compared using different lambda (thermal conductivity) values and different thicknesses. The thickness of the insulation panels is calculated based on the thermal resistance of an equivalent new insulator (orange), the average measured value (yellow) and the default value (grey). If the technical information on an insulation material is

unknown or unavailable, a default thermal conductivity value from Annex A of Belgian standard NBN B 62-002 is used to calculate the thermal resistance. The thickness is calculated based on an R-value of 4m2.kW (this is the minimum thermal conductivity that applies in the Brussels RENOLUTION subsidy-scheme for roof insulation). The black box indicates the tolerance of the test-device to take into account for the results.

Materials	type	lot	quantity	thickness	average lambda test	new lambda	default value	supplier
rockwool	mineral	1	315 m2	5 cm	0,035754	0,035	0,050	BatiTerre
					*1	*2	*3

Insulation thickness in cm to achieve a thermal resistance of R: 2,5 m2.K/W
