RENOVATION REPORT

SITE 5

A COMPOSITE ROOF WITH REUSED INTERIOR INSULATION

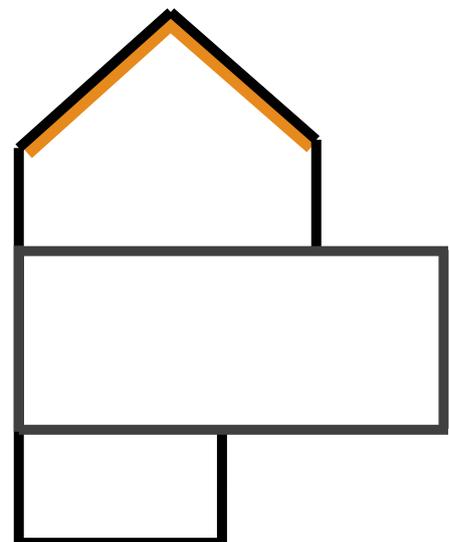
Section schématique de la typologie

This is a house divided into two flats. Several dormer windows have been created in the existing roof. The spaces under the roof will house the kitchen and living room.

Location of intervention	Shared house
Affected floors	1
Housing units	2
Year of construction/major renovation	<1930
Type of construction	timber frame
Component to be insulated	roof and dormer window
Surface area of the envelope	172
Points to consider	The beams of the wooden frame are uneven.

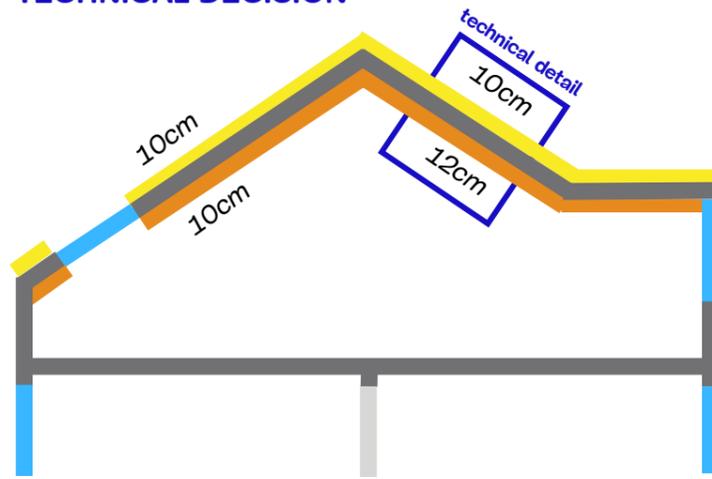
Schematic cross section

Elements to be insulated	pitched roof
Side of insulation	interior (and exterior)
Surface to be insulated	57 m2
Anchoring method	stuck between the beams
Type of insulation used	natural wool mats
Execution by	Casa Blanco

● new insulation ● reused insulation ● structure

The pitched roof was completely renovated. First, three skylights were integrated into the existing structure. The roof tiles were carefully removed, then a temporary rain screen was installed to protect the roof structure during the work. A 10 cm thick rigid wood fibre board was installed from the outside to ensure continuous insulation. A wood fibre bitumen rain screen was added to the insulation layer before the battens and counter-battens were installed.

The old tiles were then reused and replaced on the roof. Inside, flexible reused wood wool mattresses were inserted between the roof structure. These were extended using OSB panels to accommodate 10 cm of insulation on the south side and 12 cm on the north side. This difference in thickness is a consequence of the insulation available. Once airtightness was ensured, rafters were fixed in place to allow the plasterboard to be installed as the interior finish.

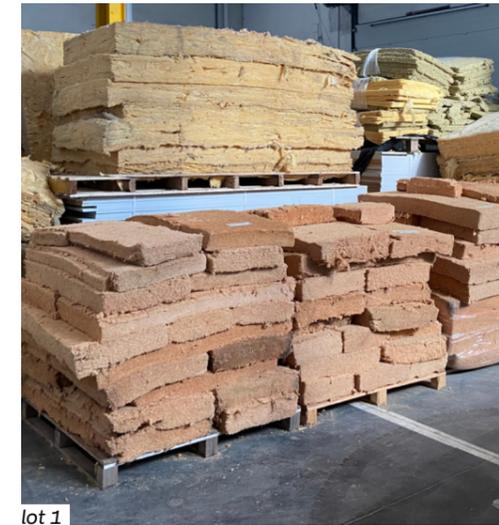
lot 1

The wood wool used on this site came from two sources. On the one hand, the insulation was recovered by Batiterre from SAAMO; on the other hand, the contractor still had surplus wood wool from previous projects. It was possible to apply insulation with a limited thickness, as it is combined with sarking insulation on the outside of the roof.

It was easier to recover a sufficient quantity of insulation material with a reduced thickness. The fact that the batches are 10 and 12 cm thick does not really pose a problem in terms of application, as they can be used on both sides of the roof (north and south).

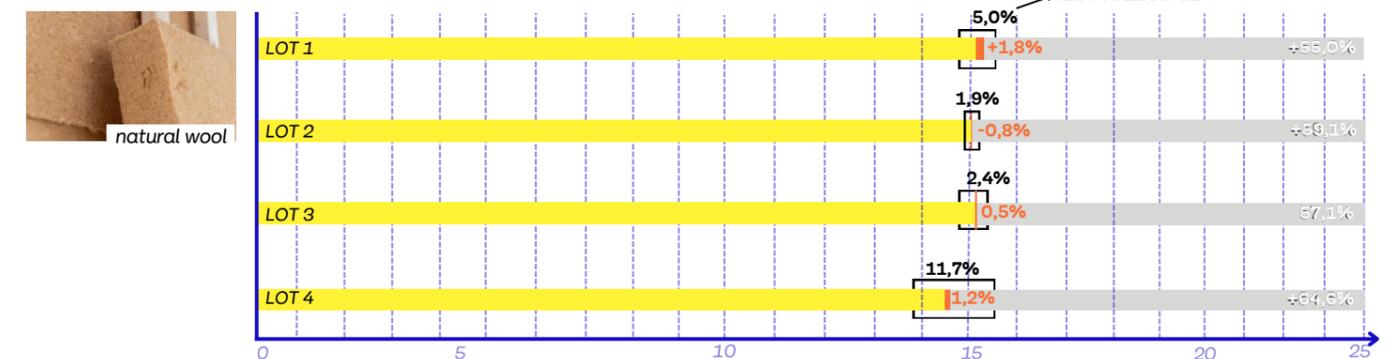
Insulation thickness in cm to achieve a thermal resistance of R: 4 m².K/W

The table below consists of two parts. First, it lists the materials used and their technical characteristics. Secondly, their thermal resistance is compared using different lambda (thermal conductivity) values and different thicknesses. The thickness of the insulation panels is calculated based on the thermal resistance of an equivalent new insulator (orange), the average measured value (yellow) and the default value (grey). If the technical information on an insulation material is

unknown or unavailable, a default thermal conductivity value from Annex A of Belgian standard NBN B 62-002 is used to calculate the thermal resistance. The thickness is calculated based on an R-value of 4m2.kW (this is the minimum thermal conductivity that applies in the Brussels RENOLUTION subsidy-scheme for roof insulation). The black box indicates the tolerance of the test-device to take into account for the results.

Materials	type	lot	quantity	thickness	average lambda test	new lambda	default value	supplier
Wood wool	Natural	1	23 m2	10 cm	0,0387	0,038	0,060	BatiTerre
		2	10 m2	12 cm	0,0377	0,038	0,060	BatiTerre
		3	11 m2	12 cm	0,0382	0,038	0,060	BatiTerre
		4	10 m2	12 cm	0,0364	0,036	0,060	Casa Blanco
					*1	*2	*3

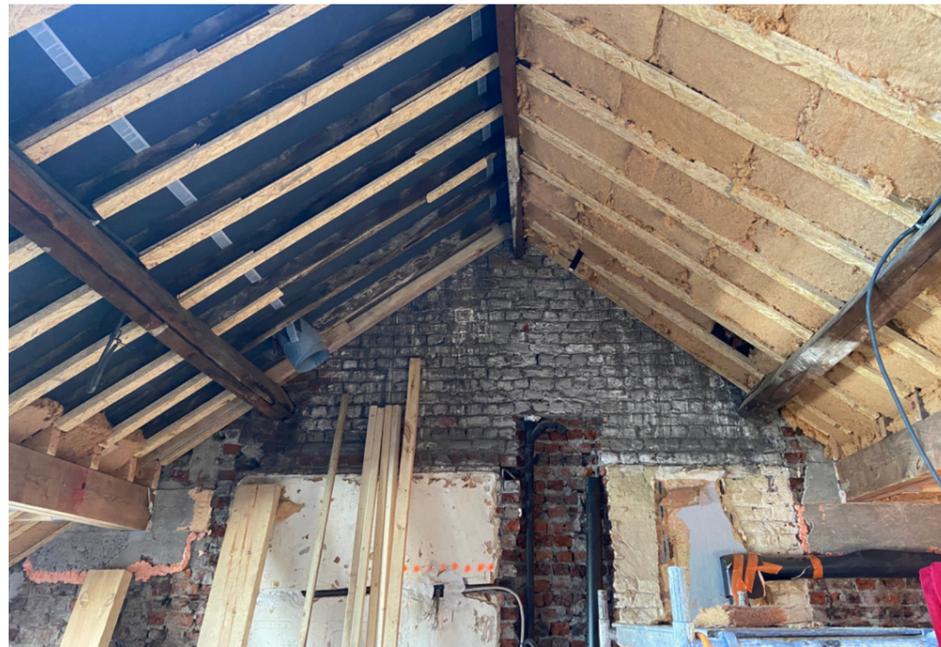
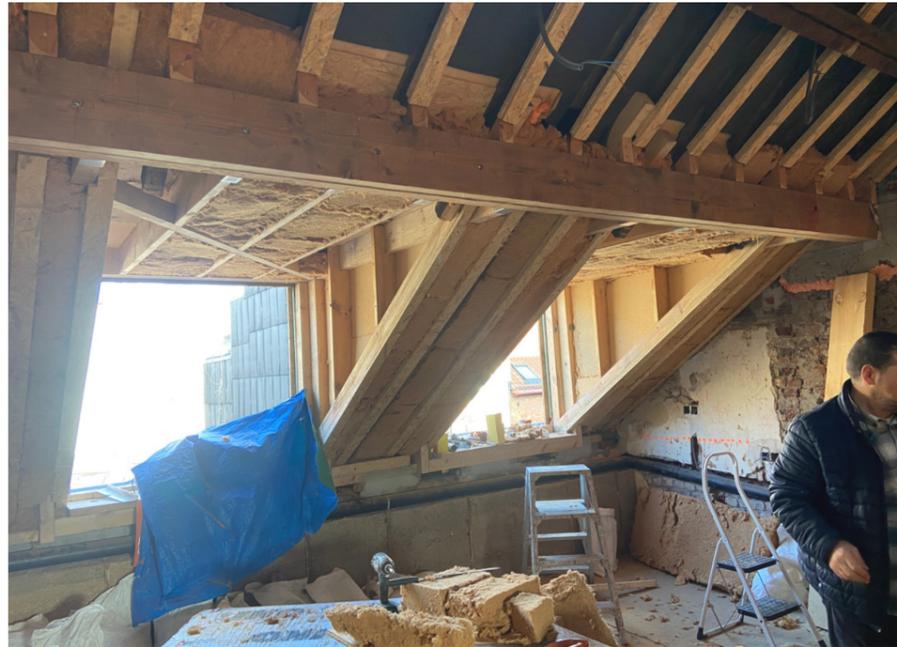
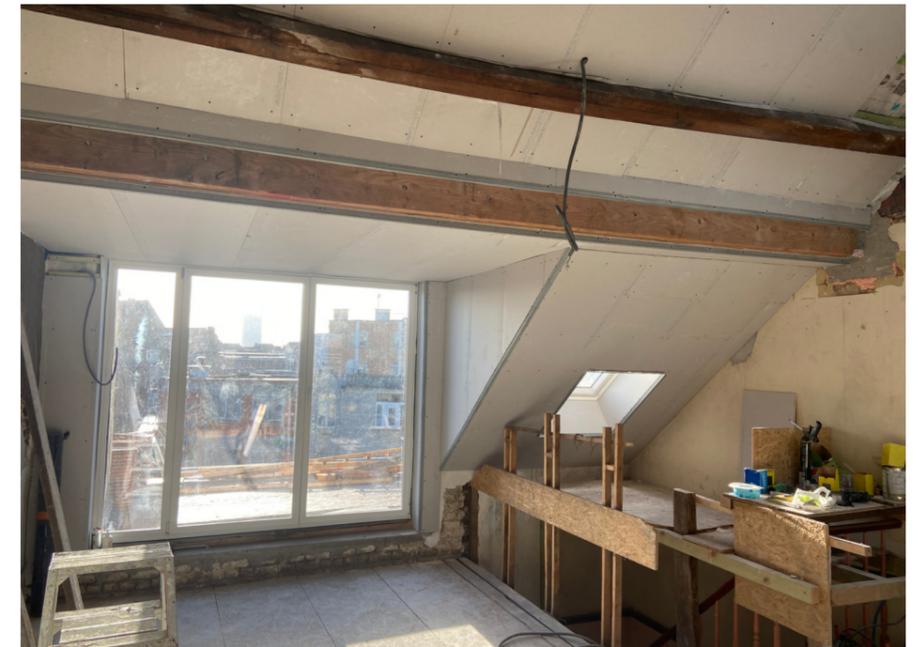
INSIDE + 10 cm new woodwool insulation + vapour barrier	57 m ²	lambda: 0,036 R: 2,8 woodfiber on the outside + 2,7	PRI: 117€/m ² 6669€ I: 20€/m²: 1140€ M: 52 €/m ² : 2964€ L: 65€/m: 3705€	<p>production 2</p> <p>energy 5,03</p> <p>maintenance 0,63</p> <p>waste 1</p>	<p>materials 3,63</p> <p>energy 5,03</p> <p>insulation 0,36</p> <p>8,66</p>	140,2 kgCO ₂ eq/m ²	0,19 W/m ² .K
