RENOVATION REPORT

SITE 7

FLAT ROOF AND INTERIOR WALLS

Attic of a single-family house used for storage

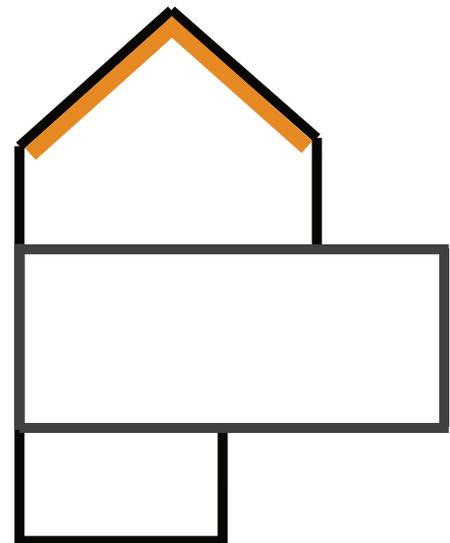
Section schématique de la typologie

Location of intervention	attic
Affected floors	3
Housing units	1
Year of construction/major renovation	<1930
Type of construction	Timber frame
Component to be insulated	roof
Surface area of the envelope	260
Points to consider	complexity of the wooden structure, with places where several beams intersect

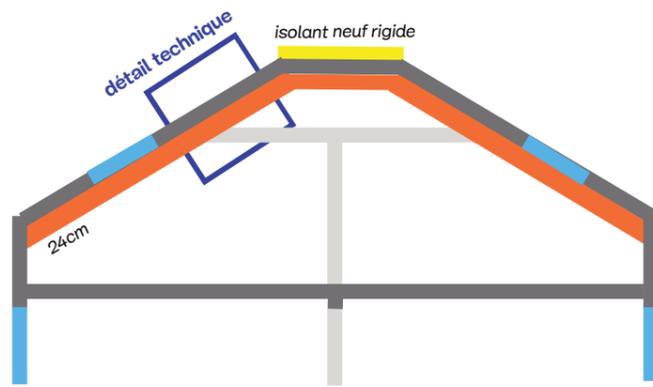
Coupe vertical schématique

● isolant neuf ● fenêtre ● isolant réemployer ● structure

Elements to be insulated	pitched roof
Side of insulation	interior
Surface to be insulated	65 m2
Anchoring method	stuck between the rafters
Type of insulation used	mineral wool
Execution by	Haracinda

Explication détail technique

The conception of this project is relatively simple. First, the beams are extended by a strip of impregnated fir wood. The glass wool is wedged between the beams. The airtight seal is applied with precision to possible puncturing. Due to the relatively large distance between the beams (up to 1 metre), impregnated fir wood strips are fixed perpendicularly to the beams to hold the insulation in place.

For the time being, no finishing layer will be applied, as this attic is currently used for storage, in order to save money and allow for future flexibility. However, the necessary electrical and lighting points are already in place.

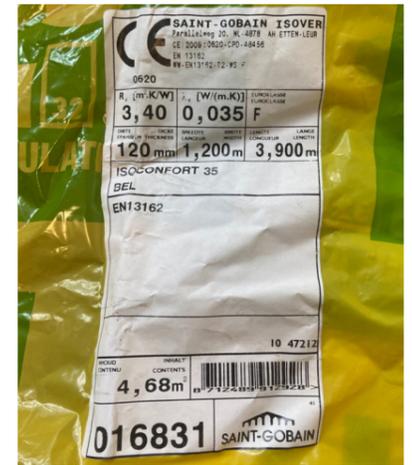
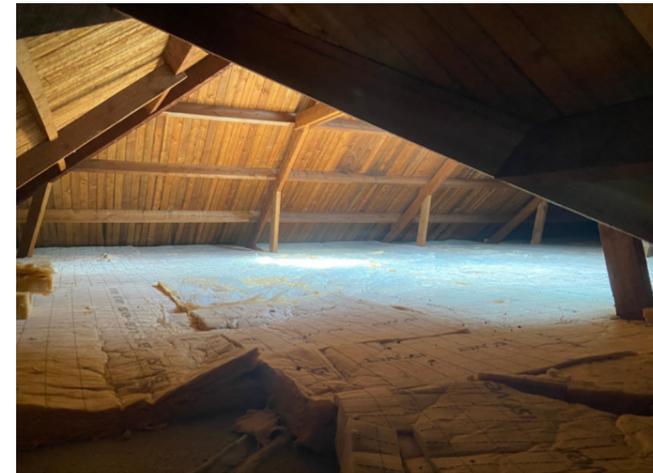
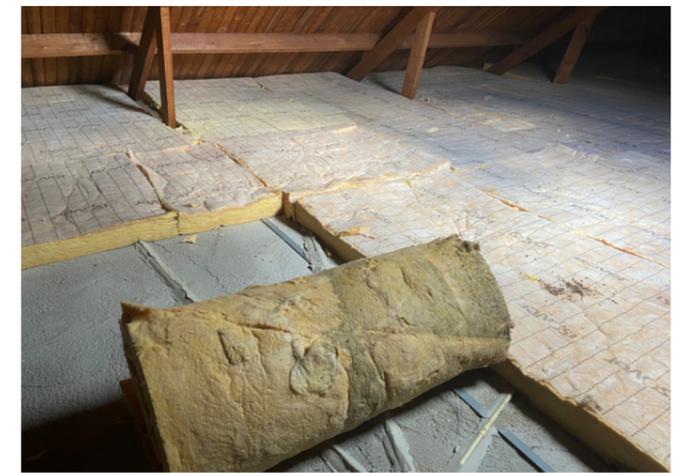
The entire roof is insulated with glass wool that came from the old insulation in an attic floor of a detached house. The access to the attic happens through a very narrow vertical staircase, which made it difficult to move the insulation. The lack of protection complicated and slightly damaged the insulation. However, because the material had been placed horizontally and had not come into contact with the outside world, it was still in very good condition.

By chance, the original packaging of the insulation was found in the attic. We therefore knew that it was ISOCONFORT 35.

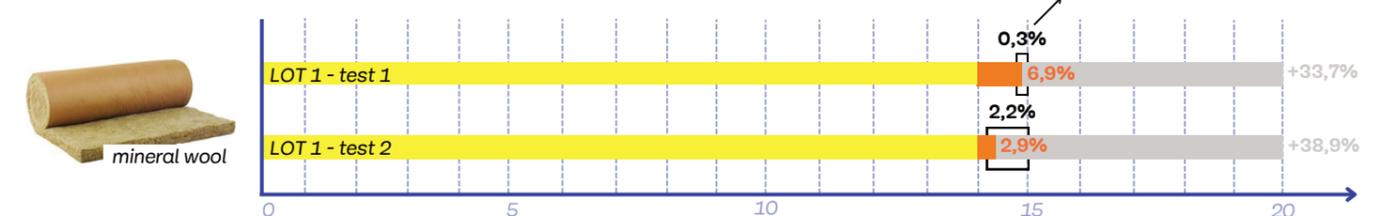
Insulation thickness in cm to achieve a thermal resistance of R: 4 m²-K/W

The table below consists of two parts. First, it lists the materials used and their technical characteristics. Secondly, their thermal resistance is compared using different lambda (thermal conductivity) values and different thicknesses. The thickness of the insulation panels is calculated based on the thermal resistance of an equivalent new insulator (orange), the average measured value (yellow) and the default value (grey). If the technical information on an insulation material is

unknown or unavailable, a default thermal conductivity value from Annex A of Belgian standard NBN B 62-002 is used to calculate the thermal resistance. The thickness is calculated based on an R-value of 4m2.kW (this is the minimum thermal conductivity that applies in the Brussels RENOLUTION subsidy-scheme for roof insulation). The black box indicates the tolerance of the test-device to take into account for the results.

Materials	type	lot	quantity	thickness	average lambda test	new lambda	default value	supplier
Glasswool	mineral	1	230 m2	4cm	0,034814	0,035	0,050	detached house
Glasswool	mineral	1	230 m2	4cm	0,032164	0,035	0,050	detached house
					*1	*2	*3

<p>average</p> <p>The additional thickness calculated using the default value is approximately 35% higher than the actual value of the material in question. However, this value did not need to be applied as there was no uncertainty regarding the type of insulation used (ISOCONFORT 35) because the packaging is found with the insulation.</p>
<p>choice materials</p>

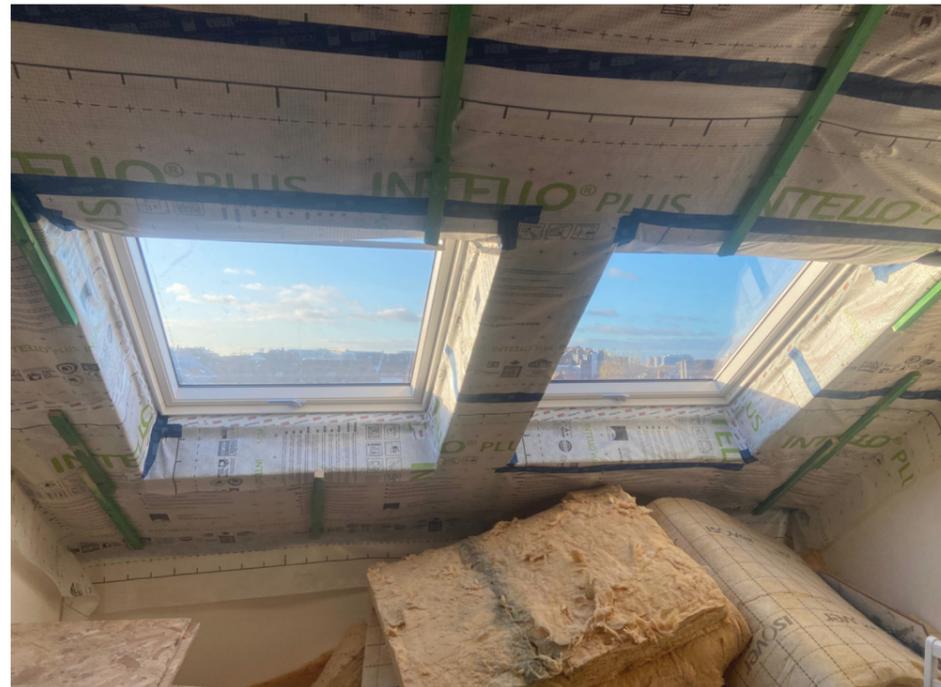
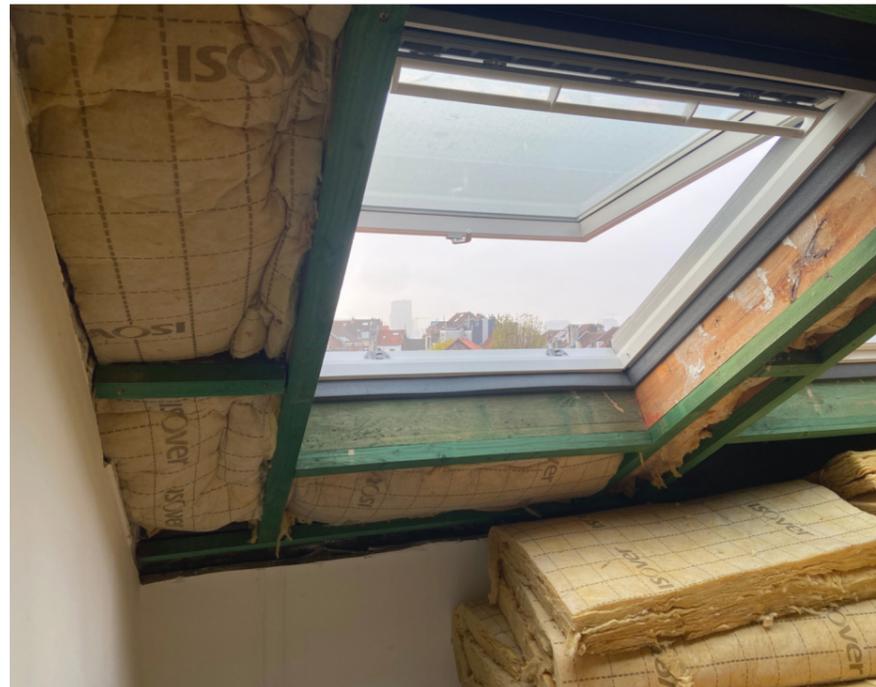
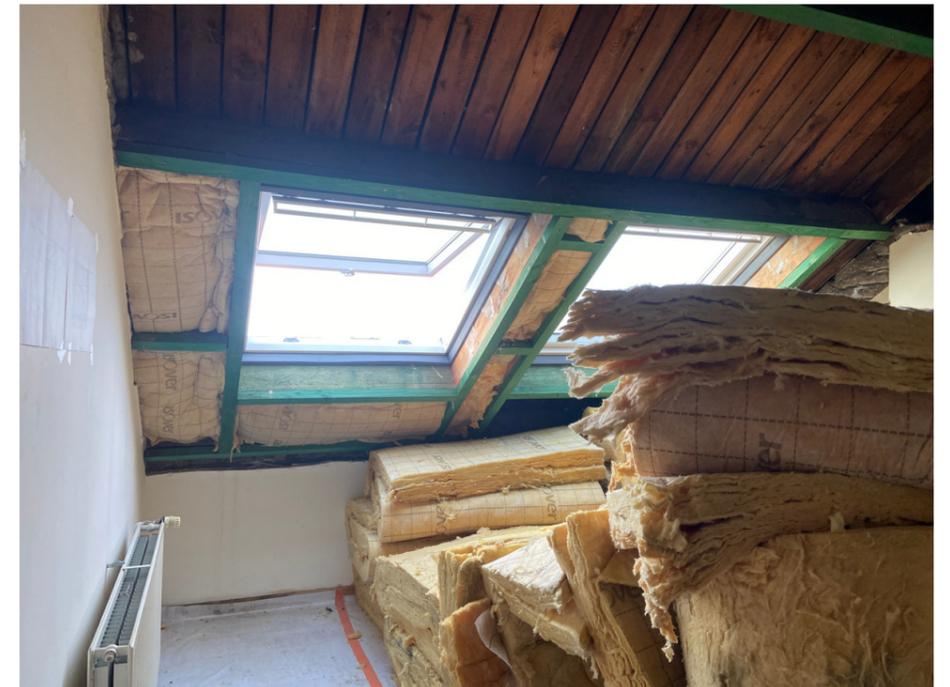
INSIDE + 12 cm glass wool insulation + vapour barrier	65 m²	lambda: 0,035 R: 3,4	PRICE: 124€/m²: 8060€ I: 14€/m²: 1113€ M: 44€/m²: 2860€ L: 80€/m: 5200€	<p>maintenance 0,23</p> <p>waste 0,23</p> <p>production 0,52</p> <p>energy 7,64</p>	<p>materials: 0,98</p> <p>energy 7,89</p> <p>insulation 0,48</p> <p>8,87</p>	172 kgCO ₂ eq/m²	0,60 W/m².K
