# RENOVATION REPORT

## EXISTING SITUATION

A storage space is converted into a communal room for a residential complex. The room is located above a commercial space, under an existing green roof.

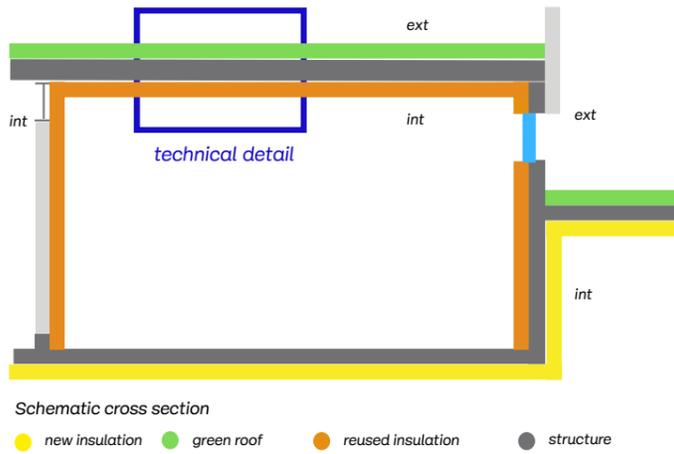
Elements to be insulated	flat roof and walls
Side of insulation	interior
Surface to be insulated	53 + 87 m <sup>2</sup>
Anchoring method	PU adhesive and screws
Type of insulation used	rigid synthetic panels and wool insulation
Execution by	Casa Blanco: Ceiling + wall with windows Self-build: 3 other walls

It is not generally recommended to insulate a flat roof from the inside, but in this case a green roof was already present, so it was not possible to insulate from the outside. Several preventive measures were taken to avoid issues with humidity in the roof composition. To avoid air pockets in the roof structure, rockwool was inserted between the grooves of the

steel sheet. Underneath the steel deck structure EPS boards of 40mm were placed. These were secured to the structure using a wooden frame. Due to the public nature of the space, double layered fire-resistant panels were used for the interior finishing, which were then plastered.
