# RENOVATION REPORT

## SITE 4

### OUTSIDE INSULATION OF A FLAT ROOF

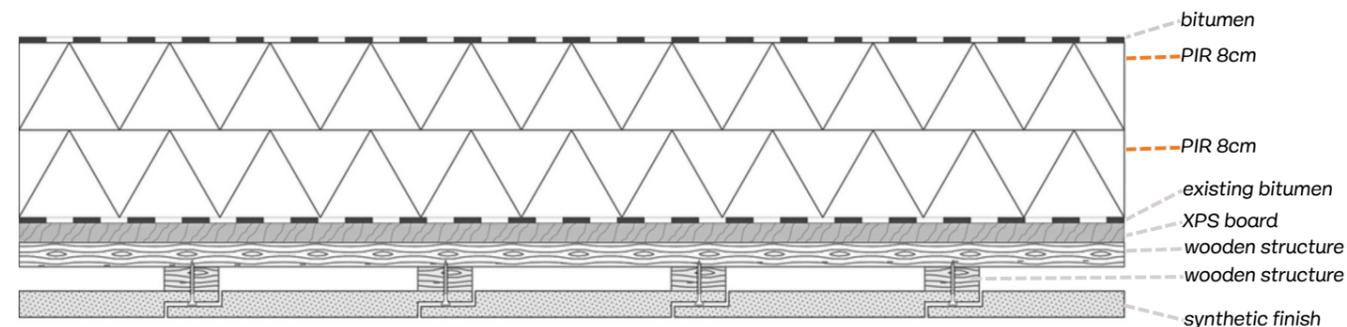
technical detail

There are three surfaces, one of which was insulated with 12 cm new insulation to achieve optimal insulation, as there was only 14 cm of height available between the window and the roof. The other two surfaces were insulated with two layers of 8 cm reused PIR panels.
