RENOVATION REPORT

SITE 8

INSULATION OF ROOF FROM THE INSIDE

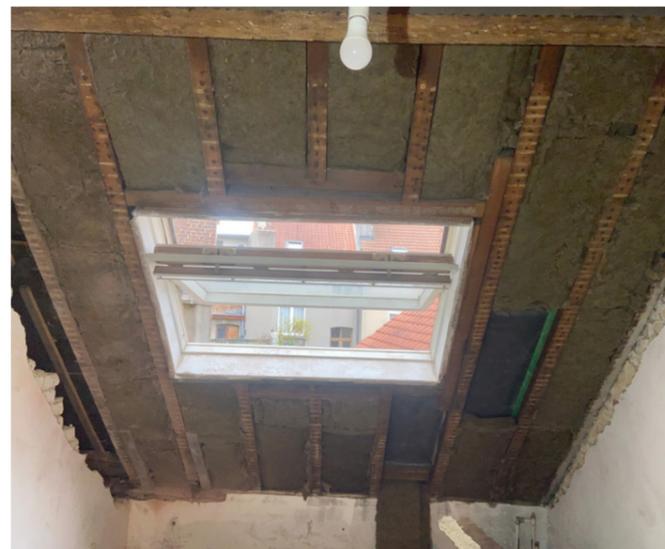
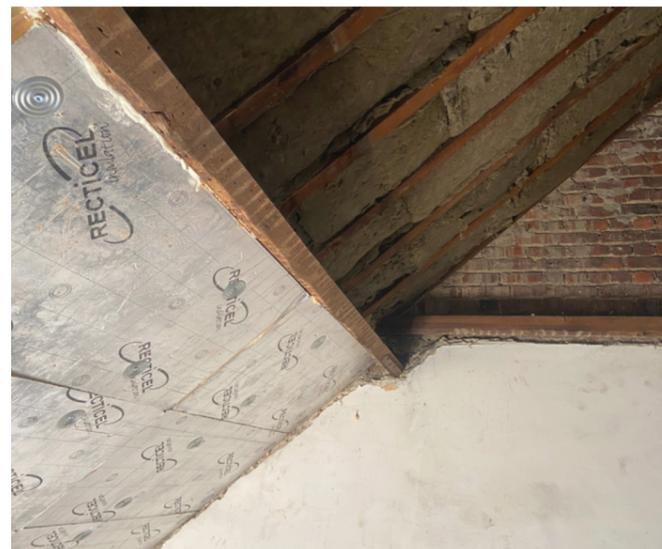
technical detail

The existing under-roof layer was slightly damaged. These defects were first repaired, battens were installed to drain any water that might have ended up behind the original under-roof and a substitute under-roof layer was installed to protect the insulation from rain and to make the assembly fully watertight. Between the joists, 6 cm of rock wool was sandwiched. The rigid synthetic insulation panels were then fixed over

the entire surface. When combining several insulation materials, the most vapour-permeable material must be placed on the cold side. An airtightness layer must be installed over the entire surface. This barrier should not be hygrovariable when combined with an original under-roof layer. Finally the finishes were installed.

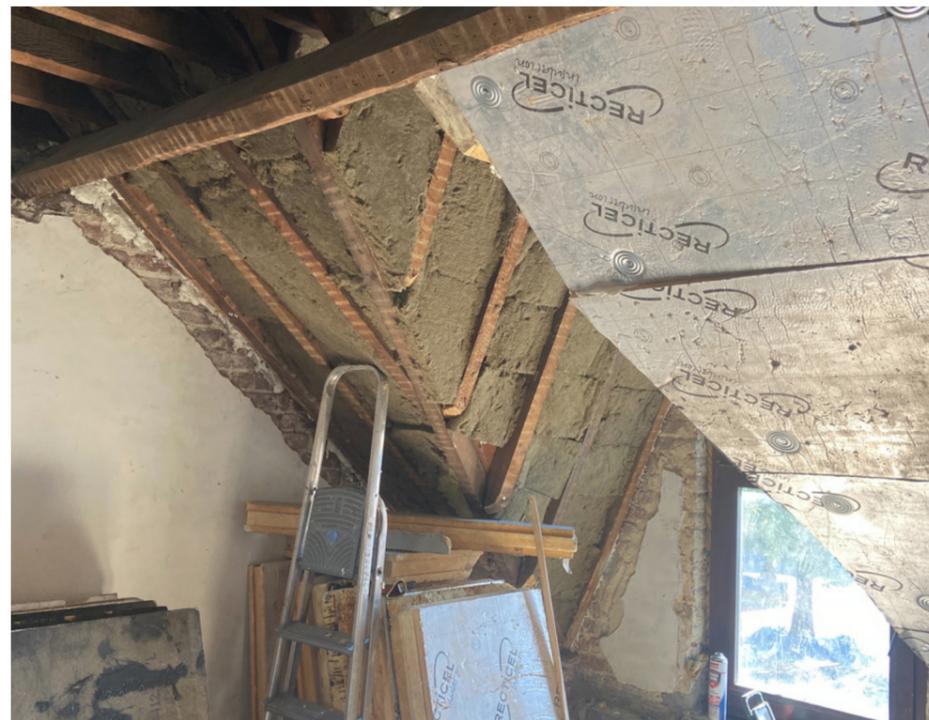
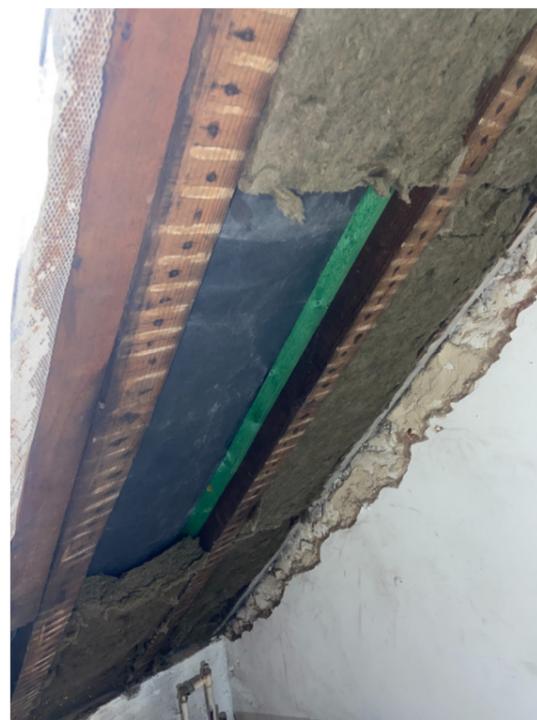
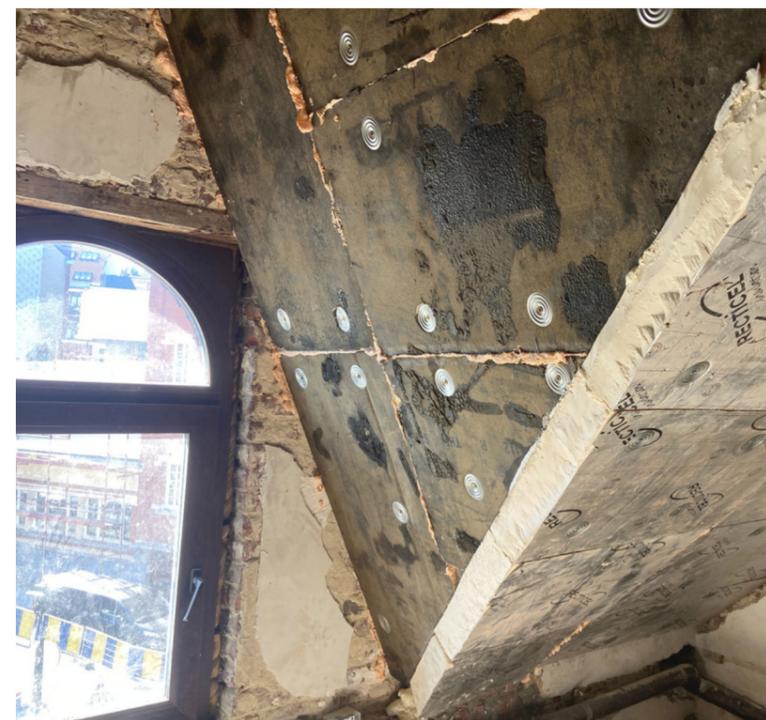
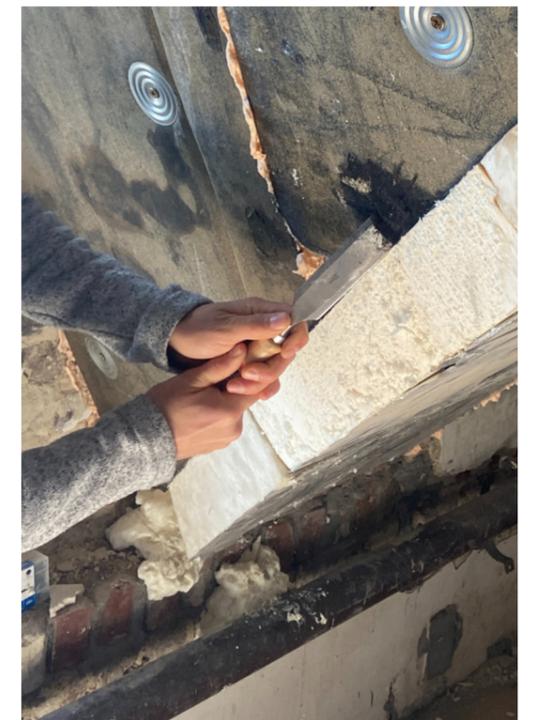
<p>average</p> <p>The rock wool and PIR panels were in very good condition. The PIR panels even still had their tongue and groove. The PUR panels, on the other hand, were in poorer condition. They still contained bitumen residues, which had to be removed.</p>	<p>sample preparation</p>

<p>average</p> <p>The rock wool and PIR panels are in very good condition and therefore only slightly deformed. The PUR panels, on the other hand, were in poorer condition and more deformed along the edges, with some of the thickness lost due to the continuous weight applied on the surface.</p>
